# TOYOTA HIGHLANDER

VIN:LVG\*\*\*\*\*5107

2016 3.5L Luxury 7-seater 4WD

Inspection Date:2026.07.20

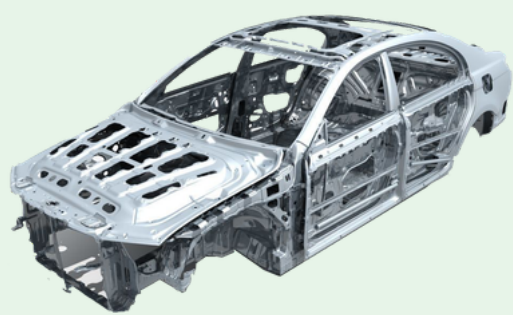
# Accident Conclusion: Accident-Free

The vehicle’ s structural components, including the front and rear longitudinal members, upper and lower side members, A/B/C/D pillars, and shock absorber mounts, as well as reinforced components such as the firewall, radiator support frame, fender inner structure, and rear panel, have been inspected across 70 accident-detection items. No signs of cutting, welding, replacement, deformation, or body repair were found. Based on the comprehensive evaluation, the vehicle is confirmed to be accident-free.

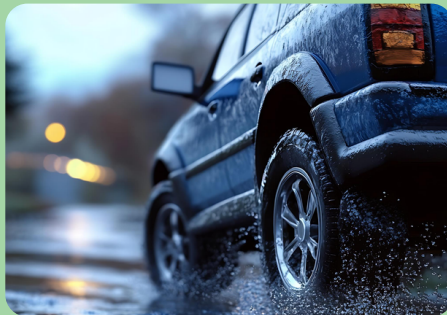
## Flood Damage Result: Flood-Free

This vehicle has undergone inspection of 31 flood-related items, including seat rails and foam, seat belts, carpets, body cavities, vehicle floor pan, as well as associated wiring harnesses and electrical components. No traces of rust, sediment, water accumulation, discoloration, or mold caused by water intrusion were found. Based on a comprehensive evaluation, the vehicle is determined to be a non-flood-damaged vehicle.

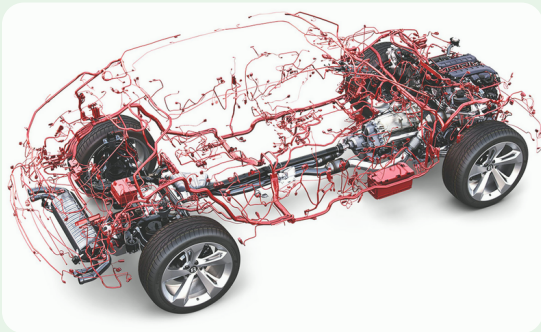
# Fire Damage Result: Fire-Free

This vehicle has undergone inspection of 23 fire-damage-related items, including engine compartment pipelines, cabin wiring harnesses and trim panels, fuel tank and fuel lines, trunk wiring harnesses and trim panels, as well as full vehicle exterior and interior coverings. No signs of soot, scorching, burning, charring, or melting caused by fire were found. Based on a comprehensive evaluation, the vehicle is determined to be a non-fire-damaged vehicle.
