# TOYOTA HIGHLANDER

VIN:LVG\*\*\*\*\*8728

2015 Model 2.0T Luxury 7-Seater AWD

Inspection Date:2026.06.03

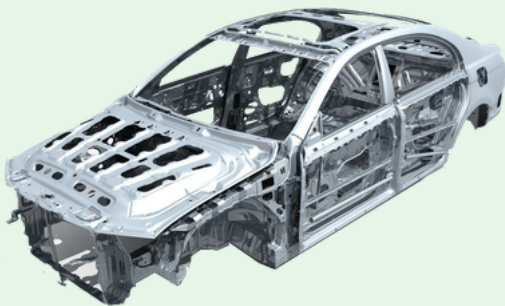
LR Quarter Panel:  
Repainted

| Defect Item 2 | | N/A 8 | |
|---|---|---|---|
| LR Quarter Panel | ! | IP Frame | ✔ |
