# TOYOTA CAMRY

## 2021 2.5L HG Luxury Hybrid

Inspection Date:2026.07.20

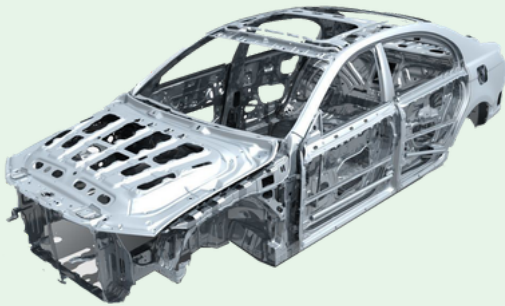
LR Quarter Panel:  
Repainted

LF Door:  
Repainted

LR Door:  
Repainted
