# TOYOTA CAMRY

## 2022 2.0L S Knight Edition

Inspection Date:2026.07.20

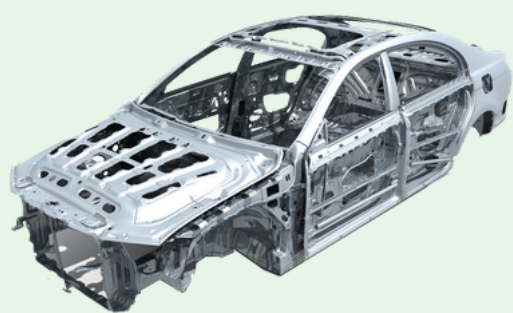
LR Quarter Panel:  
Repainted
