# Used Toyota RAV4

## 2022 2.0L Fashion PLUS Edition

Inspection Date:2026.07.20

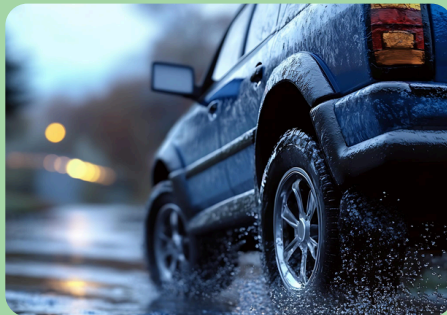
## Flood Damage Result: Flood-Free

This vehicle has undergone inspection of 31 flood-related items, including seat rails and foam, seat belts, carpets, body cavities, vehicle floor pan, as well as associated wiring harnesses and electrical components. No traces of rust, sediment, water accumulation, discoloration, or mold caused by water intrusion were found. Based on a comprehensive evaluation, the vehicle is determined to be a non-flood-damaged vehicle.
