# TOYOTA RAV4

## 2023 2.0L Urban Edition

Inspection Date:2026.07.20

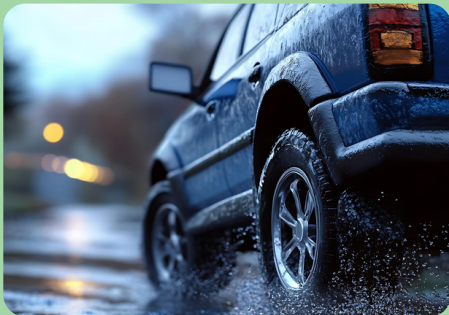
This vehicle has undergone inspection of 31 flood-related items, including seat rails and foam, seat belts, carpets, body cavities, vehicle floor pan, as well as associated wiring harnesses and electrical components. No traces of rust, sediment, water accumulation, discoloration, or mold caused by water intrusion were found. Based on a comprehensive evaluation, the vehicle is determined to be a non-flood-damaged vehicle.
