# TOYOTA COROLLA

VIN:LFM\*\*\*\*\*2076

## 2022 1.5L Pioneer Edition

Inspection Date:2026.07.20

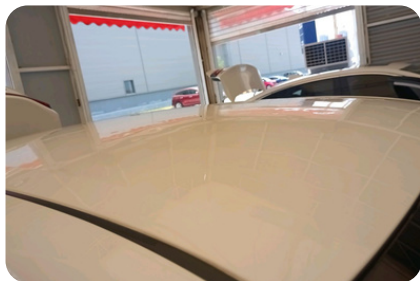
Roof Panel:  
Depression, 200mm\*300mm

| Defect Item 4 | | N/A 8 | |
|---|---|---|---|
| FLM | N/A | Roof Panel | ! |

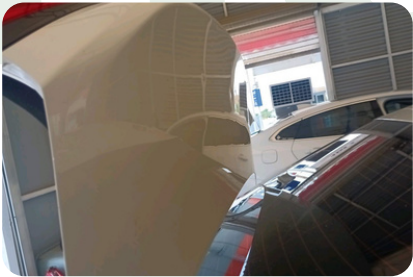
Tailgate:  
Depression,200mm\*300mm

LR Door:  
Repainted

| Defect Item 4 | | N/A 8 | |
|---|---|---|---|
| Rear Bumper | ✓ | Tail Gate | ! |
| LR Door | ! | RR Door | ✓ |

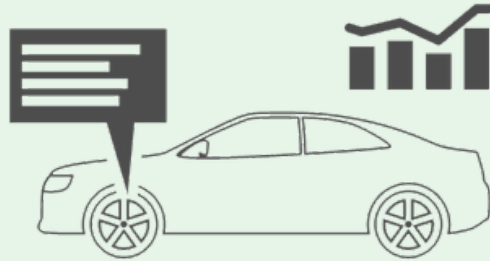
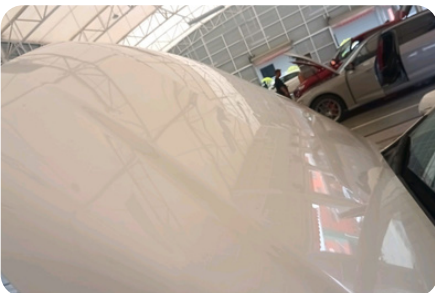
Engine Hood:  
Depression, 200mm\*300mm

| Defect Item 1 | | N/A 1 | |
|---|---|---|---|
| ENG Fuse Box | ✓ | Engine Hood | ! |
