# TOYOTA LEVIN

## 2017 1.2T Elite Edition

Inspection Date:2026.07.20

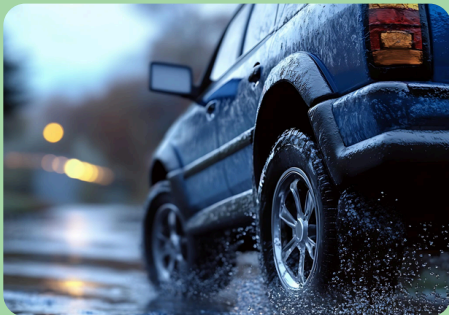
# Flood Damage Result: Flood-Free

This vehicle has undergone inspection of 31 flood-related items, including seat rails and foam, seat belts, carpets, body cavities, vehicle floor pan, as well as associated wiring harnesses and electrical components. No traces of rust, sediment, water accumulation, discoloration, or mold caused by water intrusion were found. Based on a comprehensive evaluation, the vehicle is determined to be a non-flood-damaged vehicle.

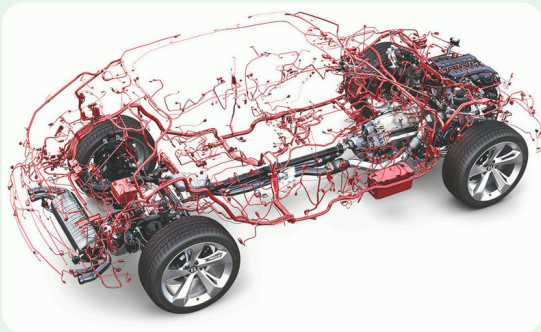
# Fire Damage Result: Fire-Free

This vehicle has undergone inspection of 23 fire-damage-related items, including engine compartment pipelines, cabin wiring harnesses and trim panels, fuel tank and fuel lines, trunk wiring harnesses and trim panels, as well as full vehicle exterior and interior coverings. No signs of soot, scorching, burning, charring, or melting caused by fire were found. Based on a comprehensive evaluation, the vehicle is determined to be a non-fire-damaged vehicle.
