# TOYOTA COROLLA

VIN:LFM\*\*\*\*\*2667

## Cross 2023 2.0L Pioneer Edition

Inspection Date:2026.07.21

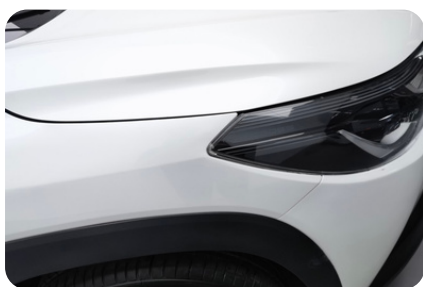
LF Door:  
Repainted

Rear Bumper:  
Replacement

LF Quarter Panel:  
Repainted

LR Door:  
Repainted

RR Door:  
Repainted

LR Tail Lamp:  
Replacement

RF Headlamp:  
Cracked, >100mm\*100mm,  
≤200mm\*300mm

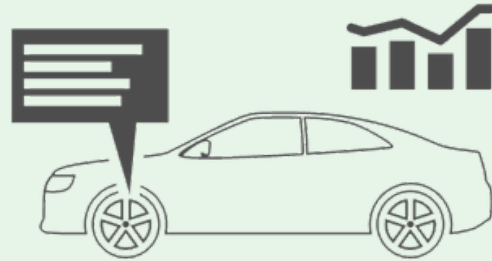
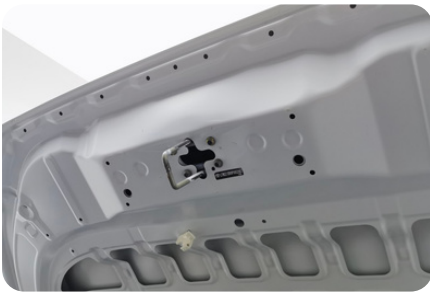
Engine Hood:  
Depression, >  
100mm\*100mm,  
≤200mm\*300mm
