# TOYOTA LEVIN

VIN:LVG\*\*\*\*\*2181

## 2024 1.5L TNGA Entry-level

Inspection Date:2026.07.20

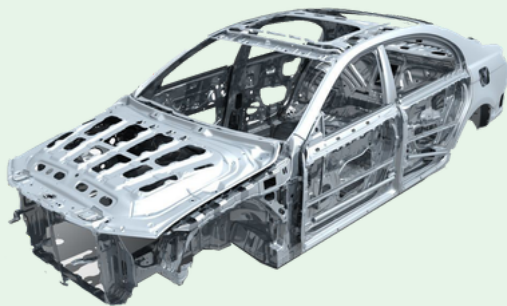
LR Quarter Panel:  
Repainted

RR Quarter Panel:  
Repainted

Rear Bumper:  
Replacement

Tail Gate:  
Replacement

LR Tail Lamp:  
Replacement
