# TOYOTA LEVIN

## 2022 Model TNGA 1.5L CVT Progressive Edition

Inspection Date:2026.05.07

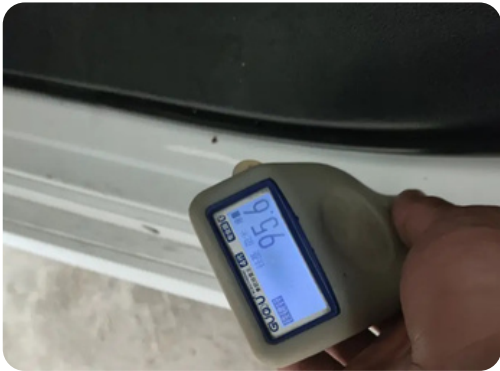
Left Side Sill:  
Scratch marks present

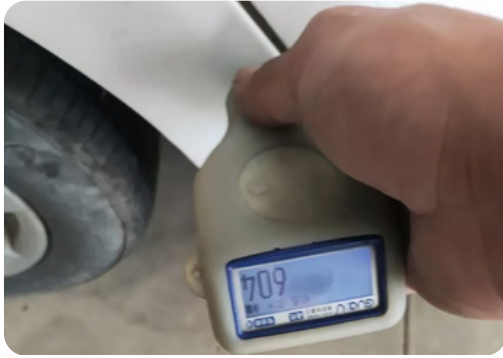
RR Quarter Panel:  
Paintwork and body repair  
present  $\geq 20\text{cm}$

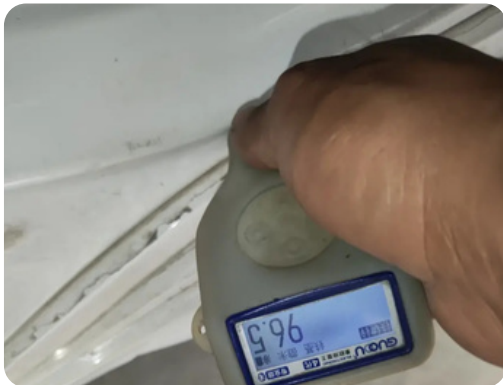
Right Side Sill:  
Scratch marks present

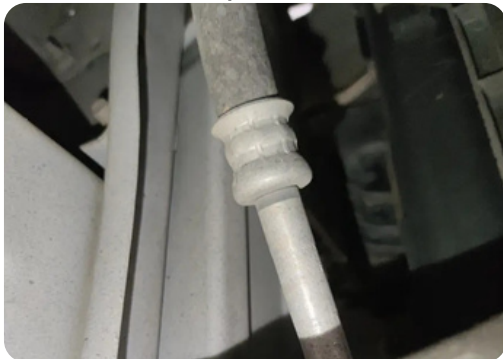
Rad Support:  
Deformation  $\geq 20\text{ cm}$  present

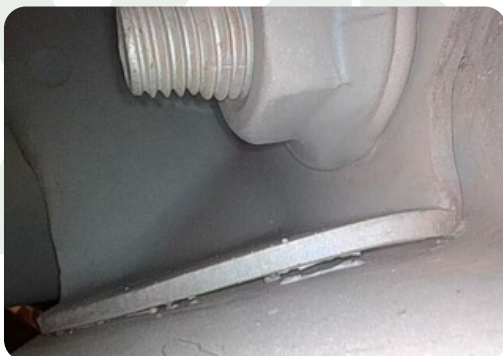
RF Long. Member Flange:  
Deformation  $\geq 3\text{ cm}^2$  present

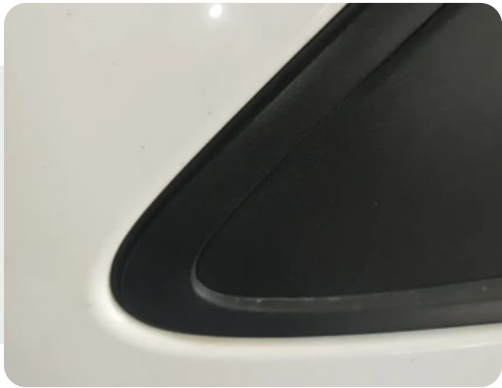
RH C-Pillar Outer:  
Paint repair present

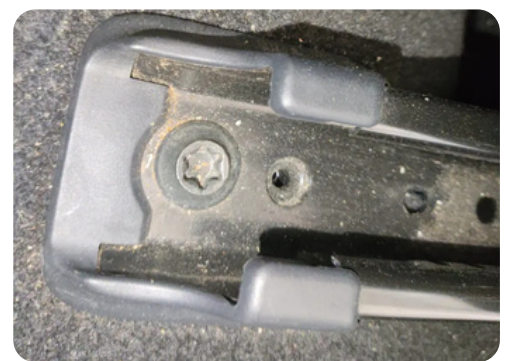
DS Seat Rail & Frame:  
Evidence of disassembly present

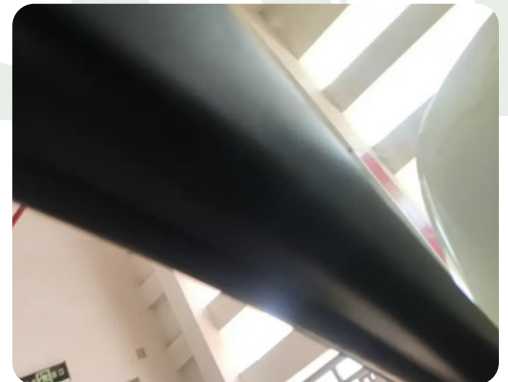
A-Pillar Trim:  
Stains present

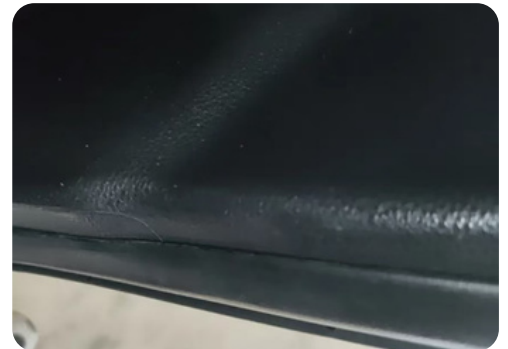
B-Pillar Trim:  
Scratches present

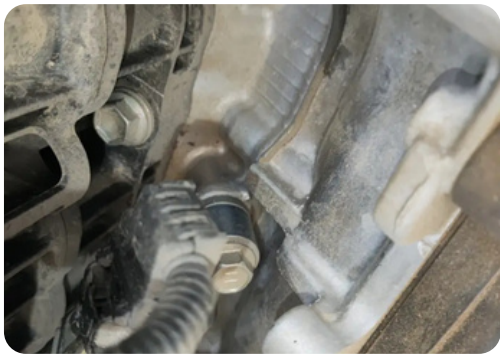
Engine Exterior:  
Signs of leakage present

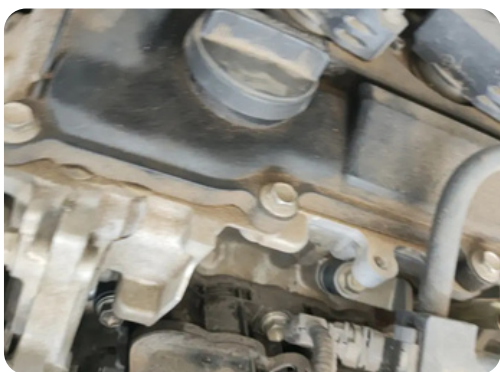
Eng. Valve Cover:  
Oil leakage present

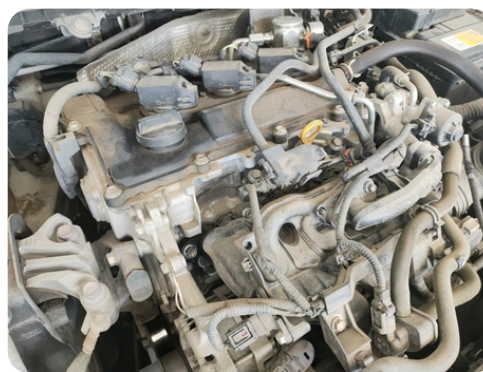
Engine Front Cover:  
Oil leakage present

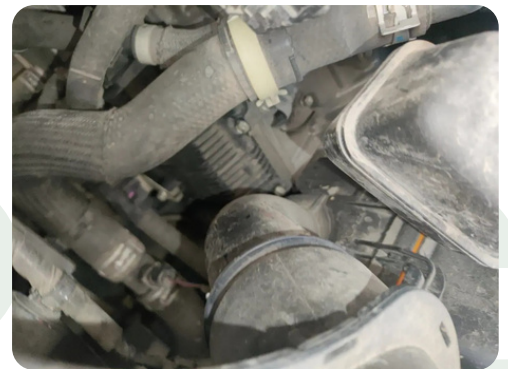
Transmission Case:  
Signs of leakage present
